## RF Deck

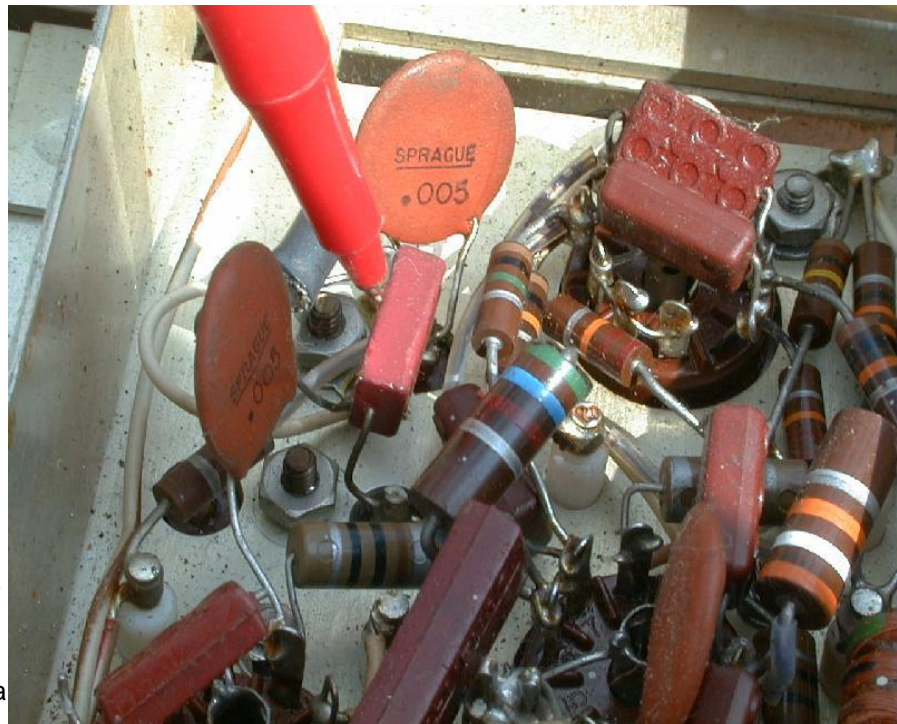
There are several concerns in the RF deck. By far, the most common, re-occurring one involves the receiver not working well or perhaps not at all on the lower bands. Checking the output of the first crystal oscillator circuit of V-207 at J-221 reveals a peak to peak output of perhaps a few hundred millivolts instead of the 3+ volts. Tuning the transformer, T-207 will not correct the condition.

This is caused by C-327, a 100pf mica capacitor failing. It is across the primary of T-207 and is accessed from the underside of the RF deck as below. It should be replaced by a 100pf, 1KV ceramic disk capacitor and the circuit re-aligned.
