Replacing C-549 and C-553

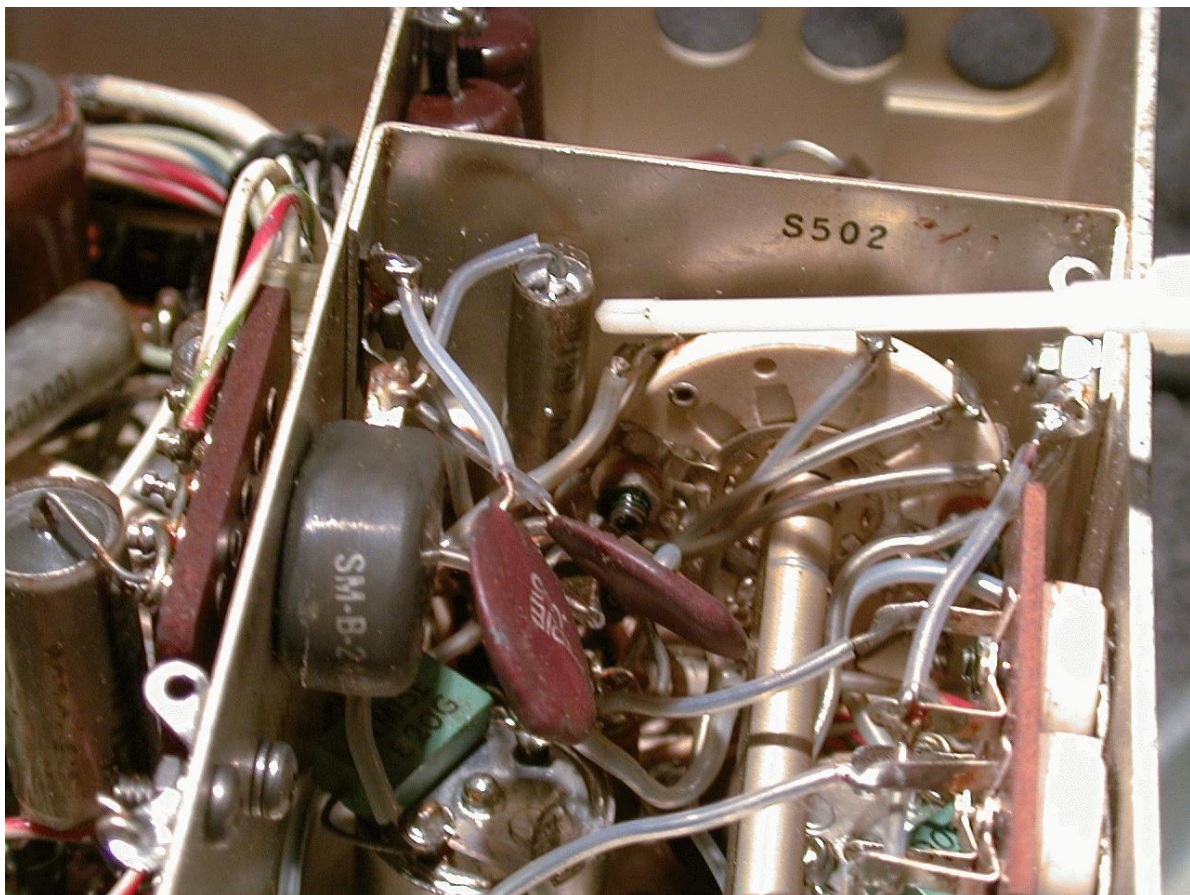
You have just experienced a failure of C-553, the blocking capacitor located between the plate of V-501 and the mechanical filters. Unfortunately, all of the mechanical filters that were selected are now also ruined and must be replaced. That is best avoided by a simple procedure to replace the C-553 which is originally a 300V Sprague "Vitamin Q" capacitor. Besides the capacitor simply being old, today's increased line voltages in turn cause an increase in receiver B+ values that run this capacitor even closer to failure.

Looking at the bottom of the IF deck, locate C-553. Its location will appear like this;

Remove the old C-553 and install a .01ufd, 600V Sprague Orangedrop capacitor in its place. Try and nest it vertically in the chassis as original. Because B+ is involved, be sure to use shrink tubing fully covering any exposed leads on the new capacitor.

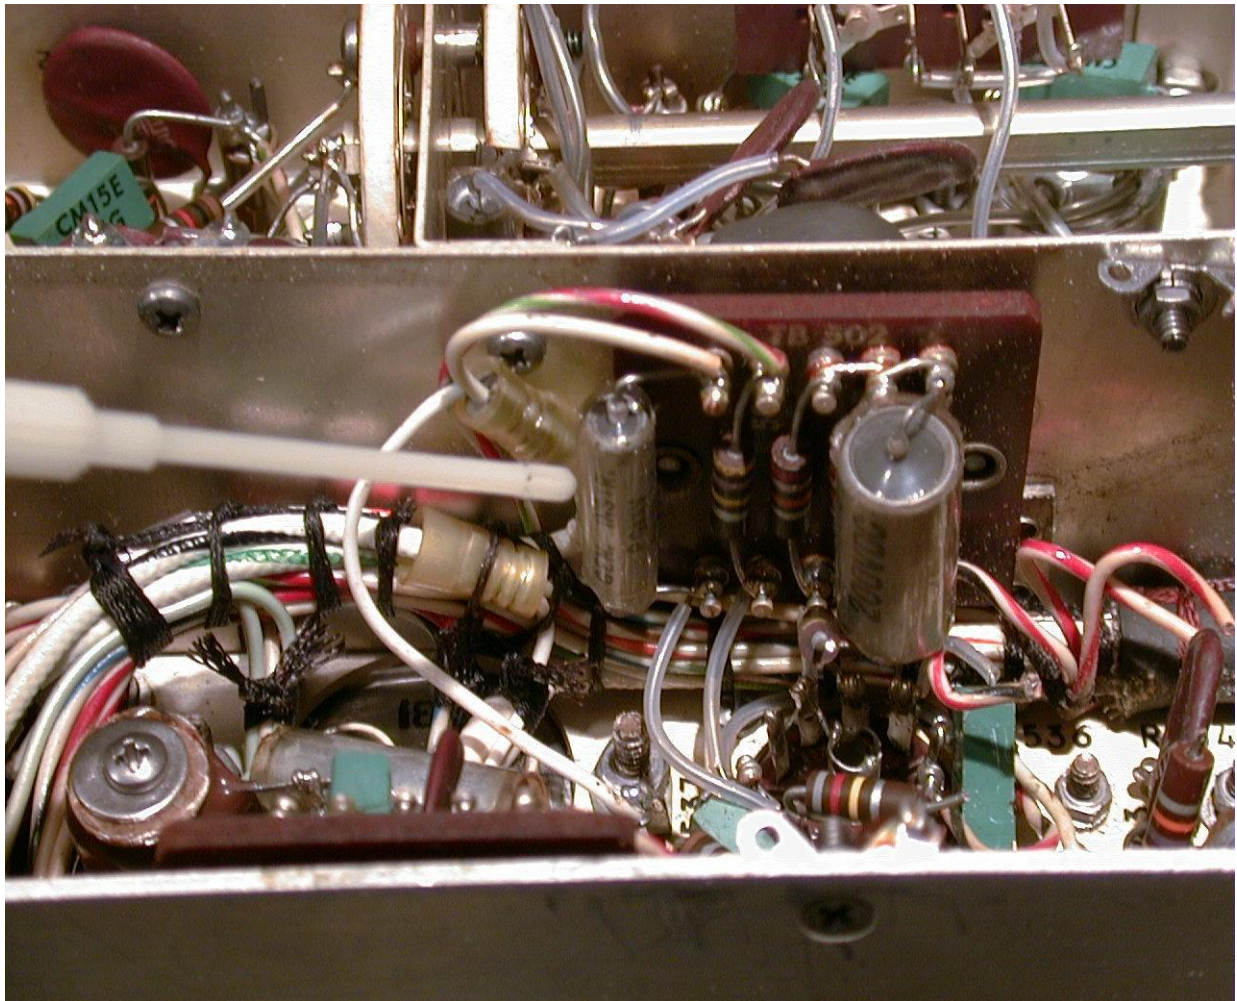
While the deck is out, its a good idea to also replace C-549. This is a blocking capacitor for the output of the limiter, V-507A. Leakage here will change the bias on the grid of the first audio amplifier, V601A causing low audio levels, distortion or complete audio shutdown. Again, replacement with a .01uf 600V Orangedrop is the solution. The location of C-549 appears as below:
